# Home Inspection Report

Inspection Address:  
**1064 Roy Avenue**  
**San Jose, CA**

Inspection Date:  
**February 2, 2004**

Report Number:  
**040202-04**

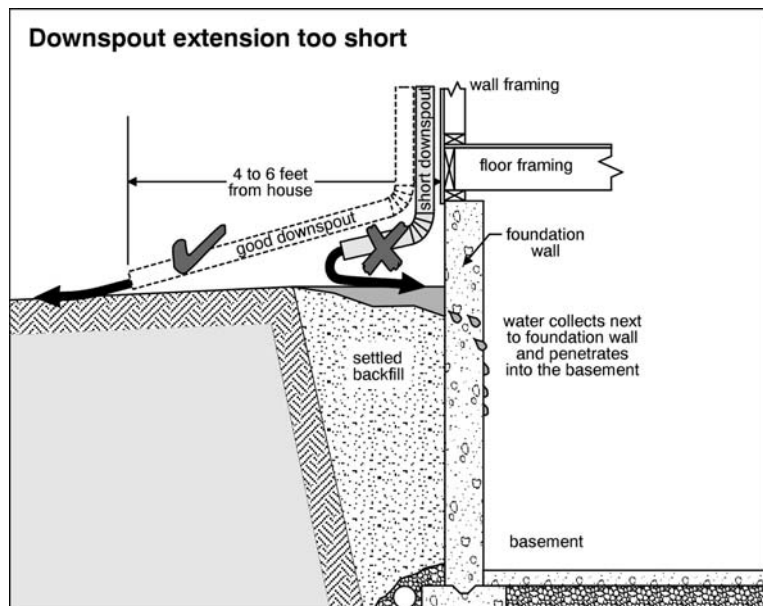
Several of the downspouts were not properly extended away from the building foundation. This condition will allow roof water to pool near the foundation, often leading to excess moisture around the foundation or in the basement and/or underbuilding crawl space. The discharge from all downspouts should be routed sufficiently away from the structure (usually at least 6' to 10') to prevent puddling, pooling, and saturation of the soil around the building.

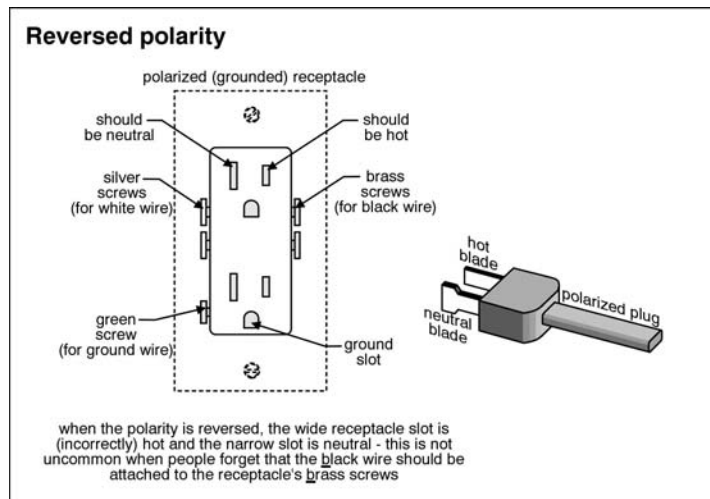
### Ground Fault Circuit Protection

GFCI (Ground Fault Circuit Interrupter) protection was installed and functioning satisfactorily for some, but not all, of the receptacles where this type of protection is presently required. We recommend upgrading of unprotected receptacles in areas where GFCI protection is presently required (including receptacles in bathrooms, kitchens, garages, basements, crawl spaces, and on the exterior). In addition, each protective device should be tested on a monthly basis.
